EXAMPLE REPORT

Photovoltaic Power Performance

Version 1.0.

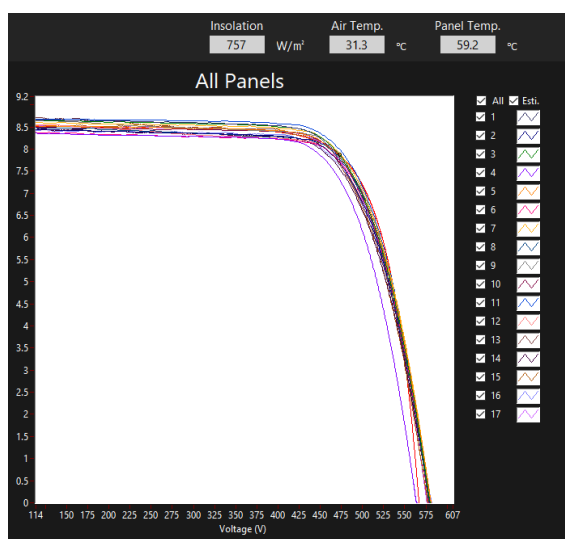
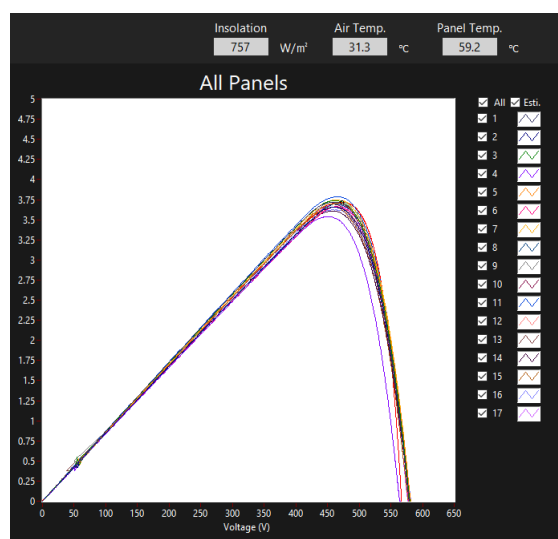
4.1.1 IV-Curve and PV-Curve

The following two figures show the IV curve and the PV curve. The IV curve is composed of the Y-current axis and the X-voltage axis. The solar irradiance, ambient temperature and module temperature at the time of measurement are shown at the top. At the right edge of the image the measured strings are displayed. The PV curve has the same structure with the difference that the Y-axis indicates the values of the power.

For this array, there was only a slight deviation (3%) from the target values based on data sheet specifications. All strings are operating as desired and delivering the expected performance. A small deviation from the target values are common as these are based on laboratory conditions, i.e. no dirt or contamination, ideal and constant irradiation without fluctuations etc.

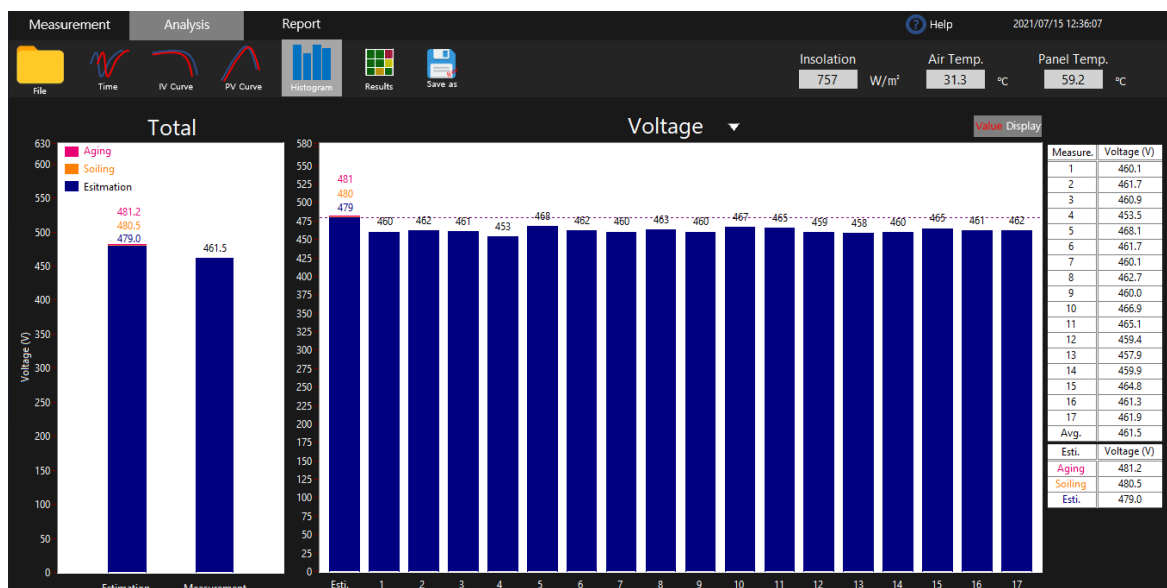
4.1.3 Voltage String-by-String

The voltage mapping is structured in the same way as the power performance, only instead of the power, the voltages are mapped here.

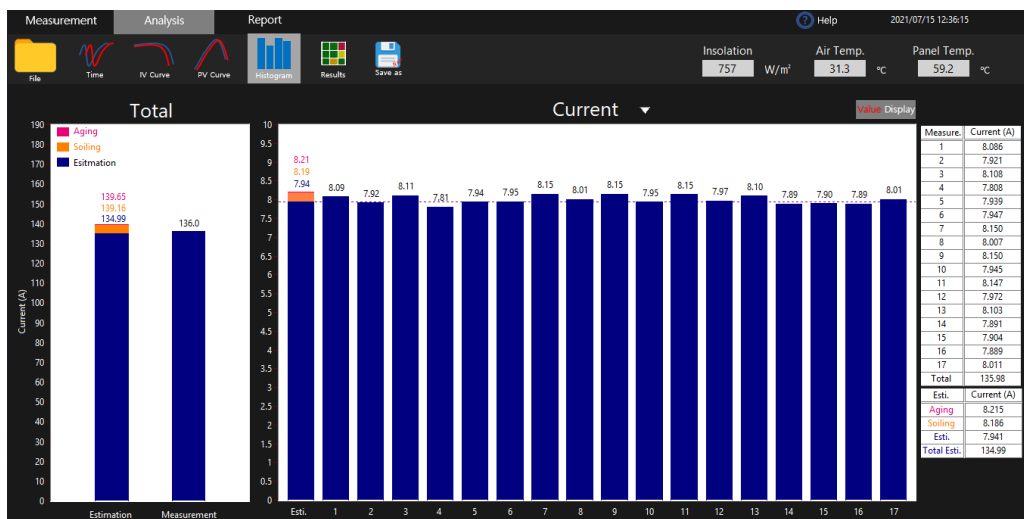
4.1.4 Current String-by-String

The currents are displayed in the same way as the voltages and powers in a bar graph. The Y-axis shows the voltage values while the X-axis shows the string numbers.

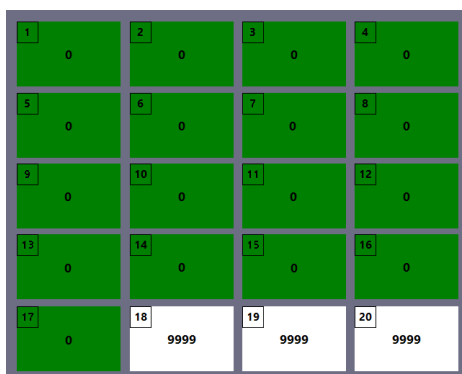
4.1.5 Automatic System Diagnosis

In the system diagnostics, faulty strings are displayed with the error category. The error category can be read in the legend.

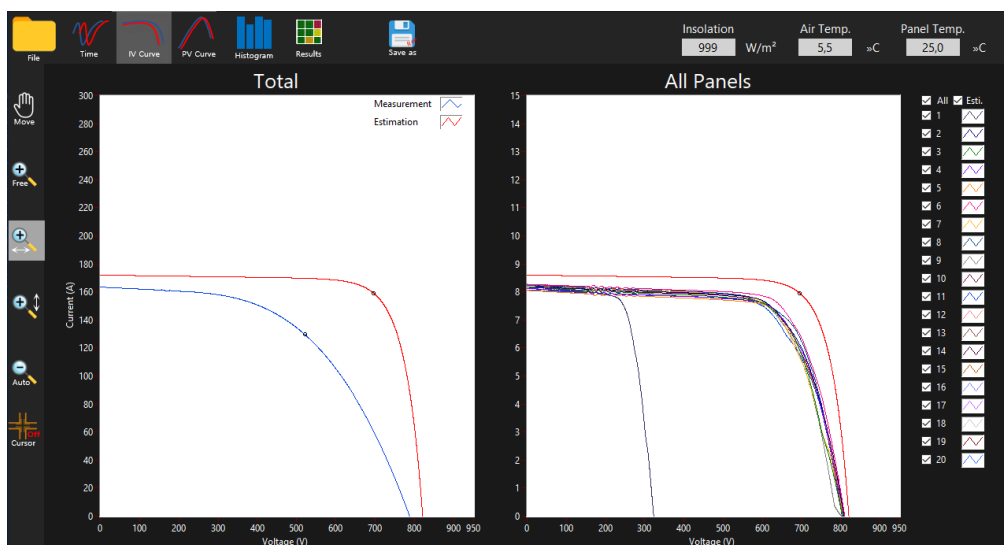
4.2.1 IV Curve

In array 2, bypass diode breaks occurred at string 1. In the power figure, it can be seen that this string has a much lower power than the other strings and consequently the overall power is reduced. Comparing the string currents and string voltages, it can be seen that the currents of the individual strings are at similar levels, but the string voltage of string 1 is far below the other string voltages and consequently reduces the overall voltage.

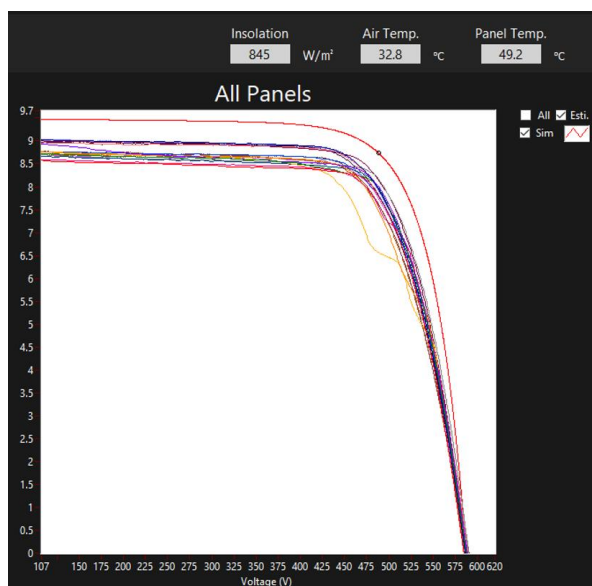
4.3.1 IV-Curve and PV-Curve

In this array, especially recognizable in the PV-characteristic curve, there are defects in three strings (string 5, 6 and 7). Modules were mechanically damaged (cell cracks, etc.) by a storm (thunderstorm with hail). Initially, only visually damaged modules were replaced by the insurance company. Due to these power performance measurements, further defective modules became visible and were finally compensated by the insurance company. This example emphasizes the need of full IV curve analysis, as comparing short-circuit current or open-circuit voltage of the strings will not show this error.

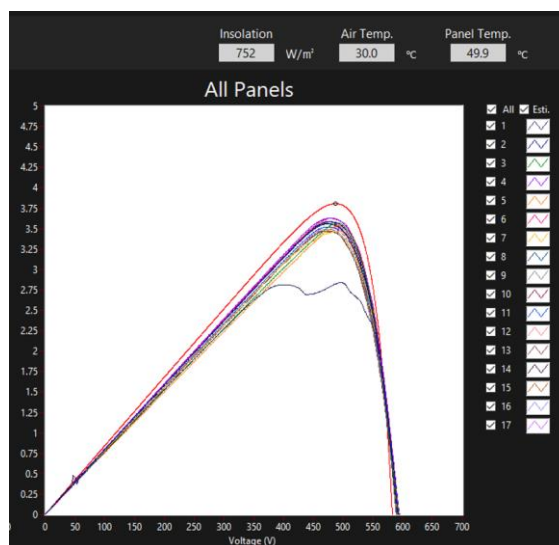
4.4.1 IV-Curve and PV-Curve

Note: One string is affected by *near shading*.

In this array, there is an 8% power reduction in string 1 due to near shading from plant growth. The lower voltage on string 1 reduces the total voltage of the array and thus the total power. The resulting parallel mismatch losses are 7%. The total power of the array is reduced by 15% overall.

Regular safety checks are recommended to minimize the risk of fire and electric shock. During this measurement, three strings were found with leakage currents that could not be measured. These faults should be corrected immediately. To avoid mismatch losses, strings should not be continuously shaded and avoidable shading should be removed. Modules that were defective due to the storm should be replaced with new ones. Regular checks for hotspots and defective bypass diodes are also recommended, as these pose a fire hazard in addition to power losses. Regular power performance tests are recommended to detect performance reducing factors and to identify defective modules at an early stage. Finally, regular power performance tests ensure safe operation and are ensuring generation of the maximum possible yield.
